CULTURAL LANDSCAPE REPORT FOR VANDERBILT MANSION NATIONAL HISTORIC SITE

VOLUME II: TREATMENT

HYDE PARK, NEW YORK

By John W. Hammond, Historical Landscape Architect

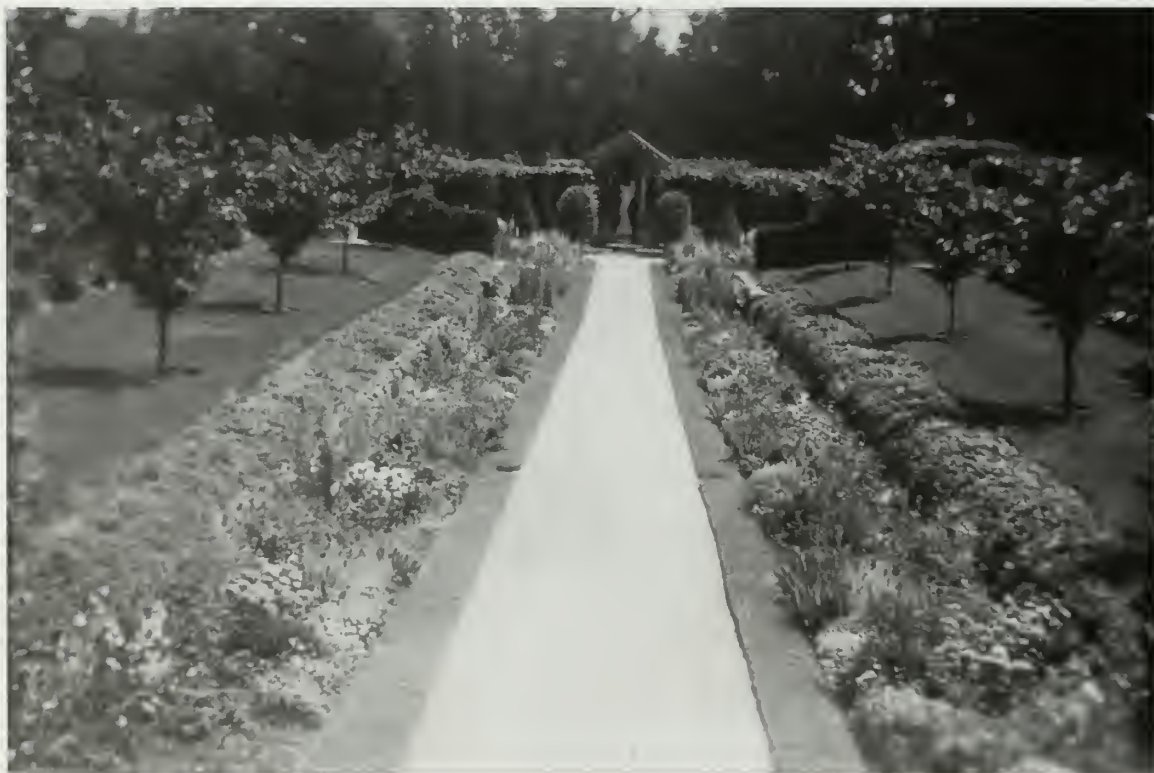
Figure 14. View of the upper perennial garden looking south, circa 1934 (VAMA no. V-114).

Frederick Vanderbilt planted numerous trees over the course of his residency. These included specimen trees throughout the property, an allée of sugar maples along the entry drive, and a white pine buffer along Albany Post Road. The overall layout and character of the estate grounds, however, appears to have been largely retained. The Vanderbilts also employed a series of landscape architects to redesign the formal gardens constructed by Walter Langdon, Jr. in 1875. Early changes to the gardens included the replacement of the greenhouses with three new greenhouse structures: the Carnation House between the existing Tool House and Gardener’s Cottage, the Rose House, and a pair of Palm Houses. The gardens were also redesigned and extended eastward, with major redesigns of the two eastern-most terraces designed by James L. Greenleaf and the addition of the rose garden designed by Thomas Meehan and Sons and Robert B. Cridland. New structures in the gardens included walks, walls, arbors, pavilions, pools, and fountains (Figure 13). Changes to the gardens were carried out over several years from 1905 to about 1932, when the Italian garden designed by Greenleaf, with its dense plantings of evergreen shrubs and hedges, was redesigned by Cridland as a flowering cherry allée with perennial border beds (Figure 14).

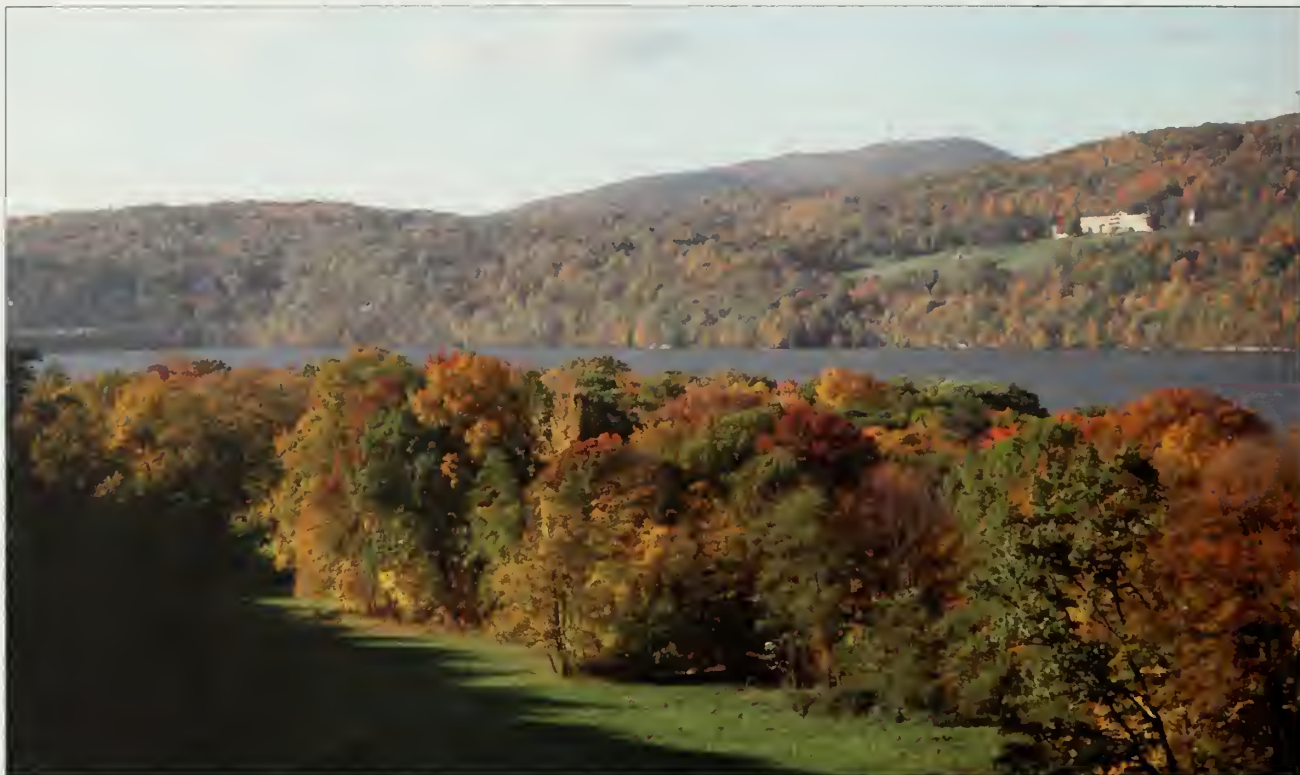
Figure 17. View of woodlands along the banks of the Hudson River looking south from near the Mansion (OCLP 2008).

Woodlands: Woodlands occur in long contiguous belts, primarily along the river bank, on the slopes below the terrace, and along the course of the creek (Figure 17). Woodlands include deciduous woodlands, dominated by oaks, maples, and tulip trees and nearly free of conifers; planted conifer groves consisting of single-aged stands of white pine, hemlock, and spruce; and mixed woodland, located primarily along the creek. The composition and character of the woodlands appears to have changed little over the years, but the extent of the woodlands have increased in recent years, with historical evidence indicating that woodlands today cover considerably more of the grounds than they did during the historic period. Aerial photos indicate that woodlands now cover ten to fifteen percent more area than they did in 1938.

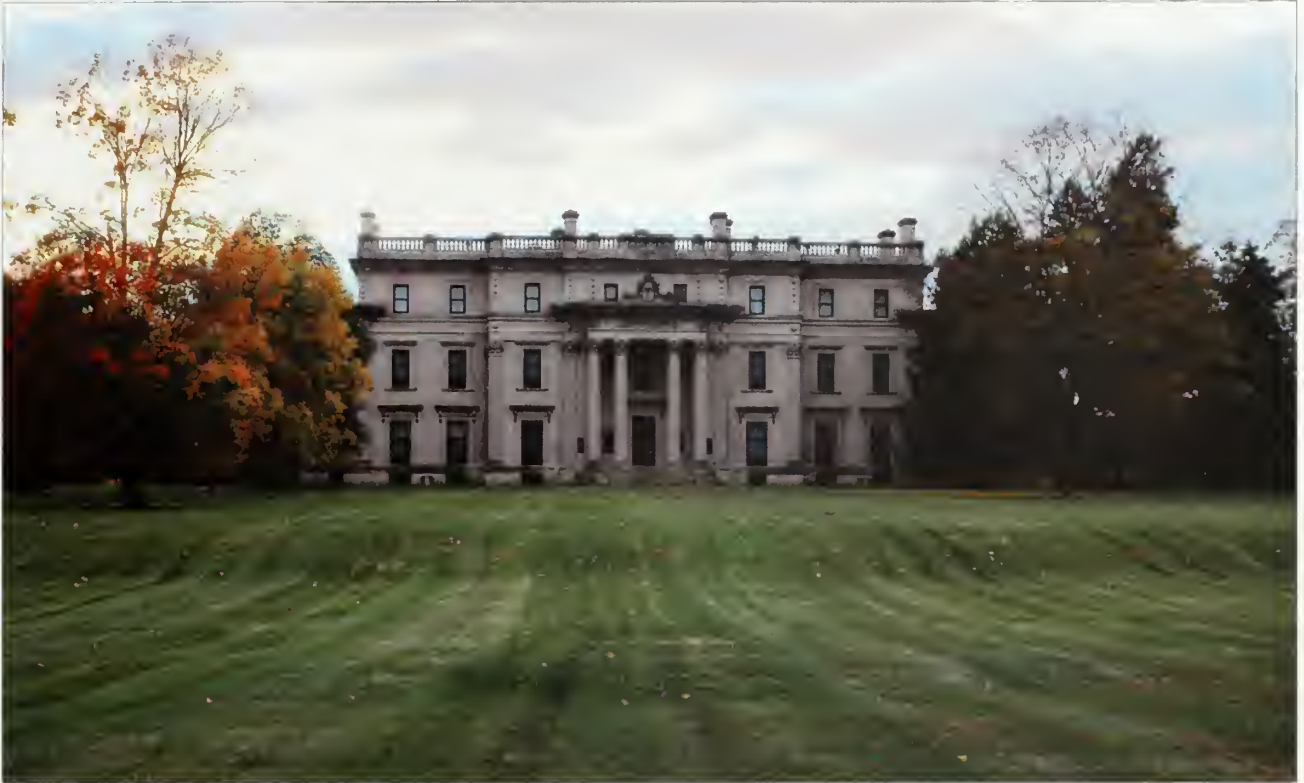
Figure 19. View of Vanderbilt Mansion and East Lawn looking west (OCLP 2008).

Lawn: Much of the property is covered by lawns maintained with turf grass mowed regularly to a couple of inches (Figure 19). Lawn areas are concentrated

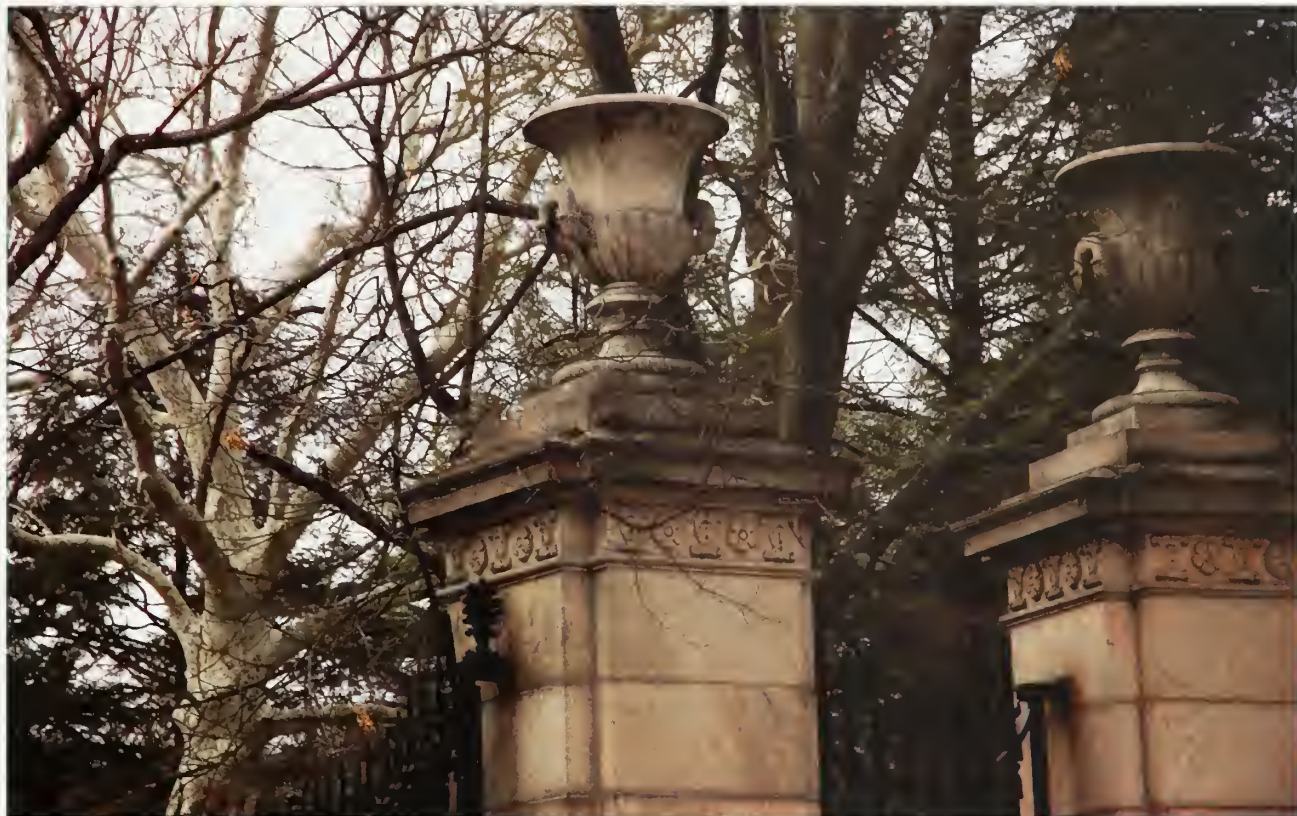
Figure 25. View looking northwest of the Main Gate piers and urns with encroaching limbs, moss, and weeds (OCLP 2008).

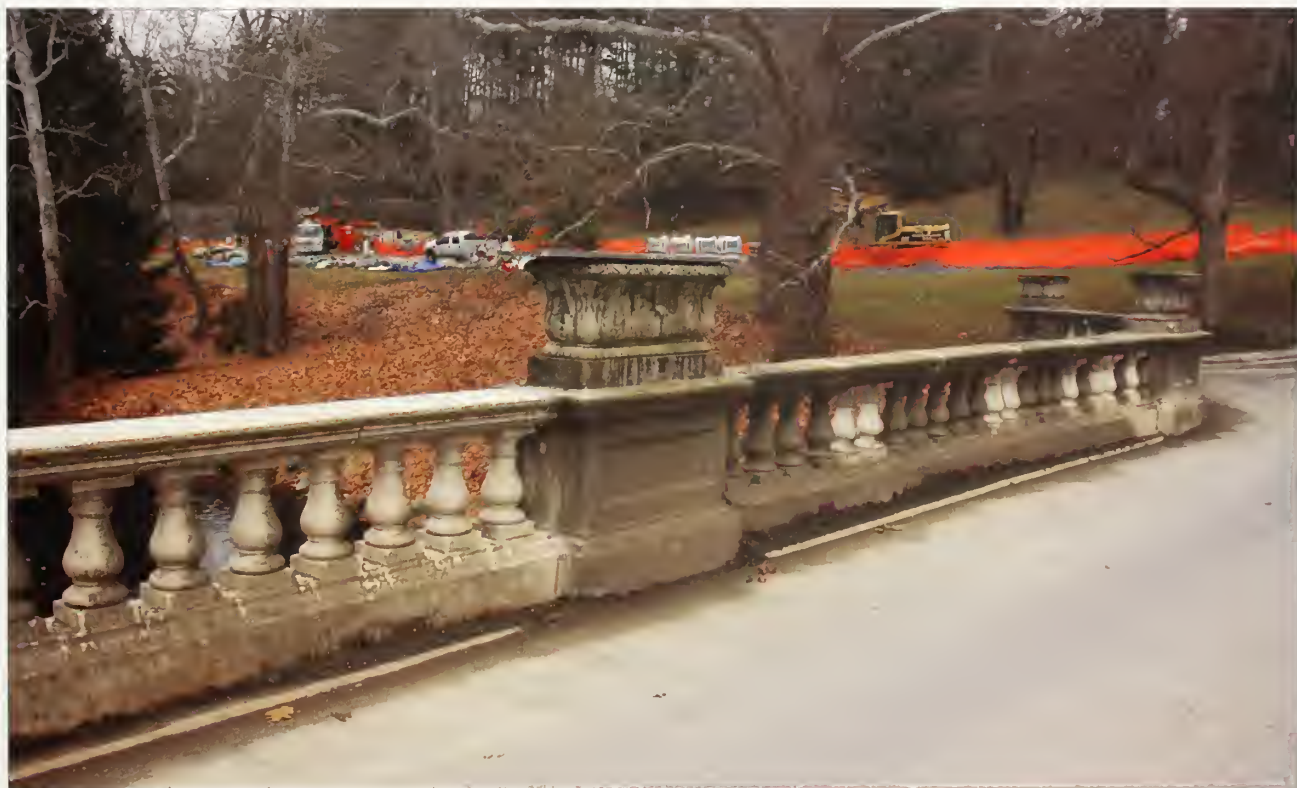
Figure 26. View looking northeast of the White Bridge, showing recent restoration work. Construction associated with the Route 9 bridge is visible in the background (OCLP 2008).

26.	View looking northeast of the White Bridge showing recent restoration work, 2008.	123
27.	Damaged cast stone curb at the Main Gate, 2008	124
28.	View of the Main Gate looking northwest, circa 1930s.	124

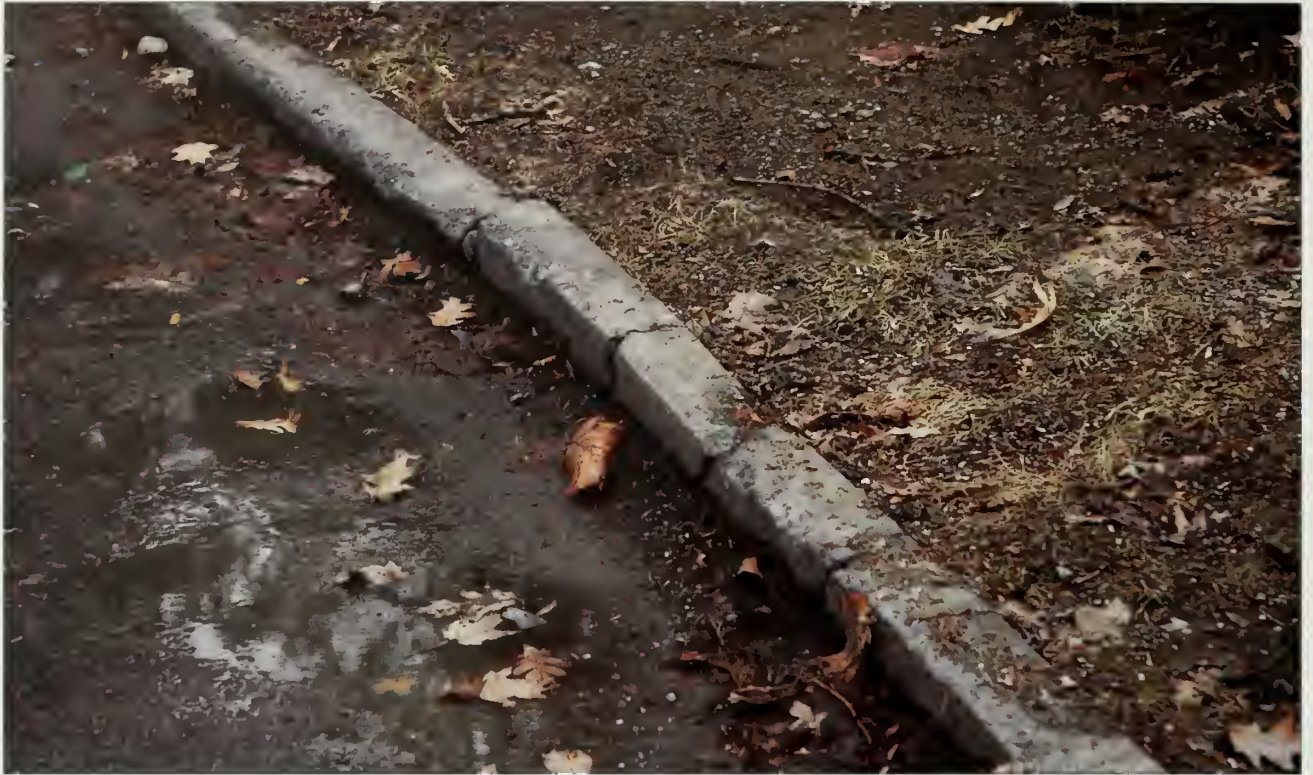
Figure 27. Damaged cast stone curb at the Main Gate (OCLP 2008).

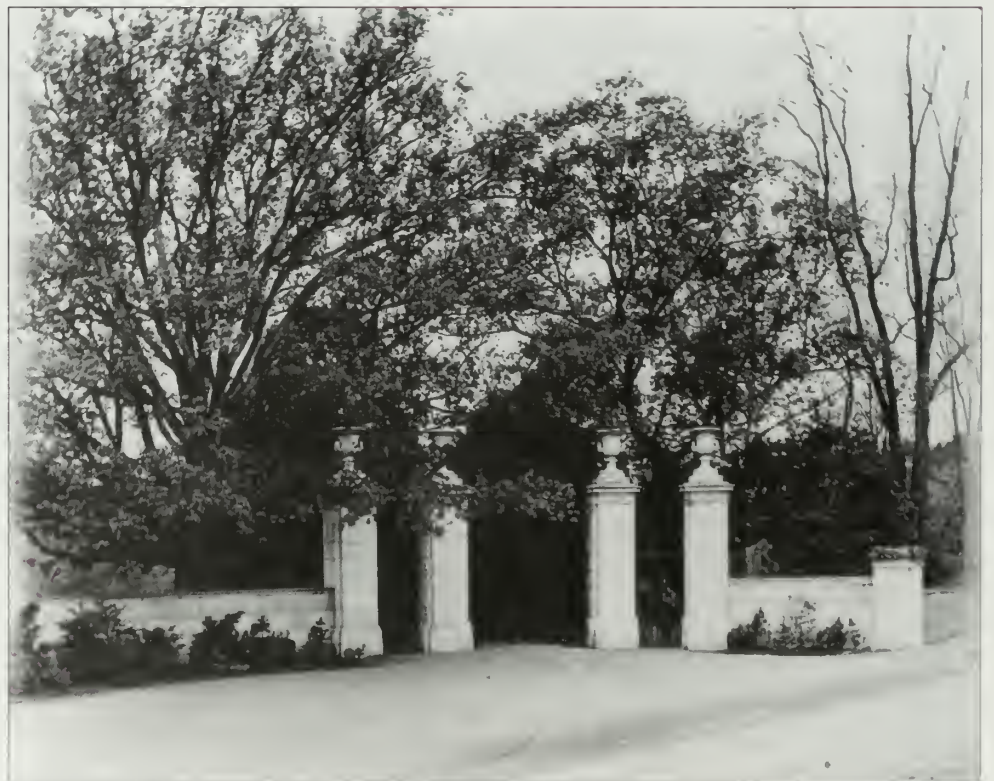
Figure 28. View of the Main Gate circa 1930s, looking northwest. The photo shows a variety of mostly conifer shrubs planted irregularly in front of the gate walls. Note that none of the shrubs extends above or fully obscures the wall (Hyde Park Historical Society).

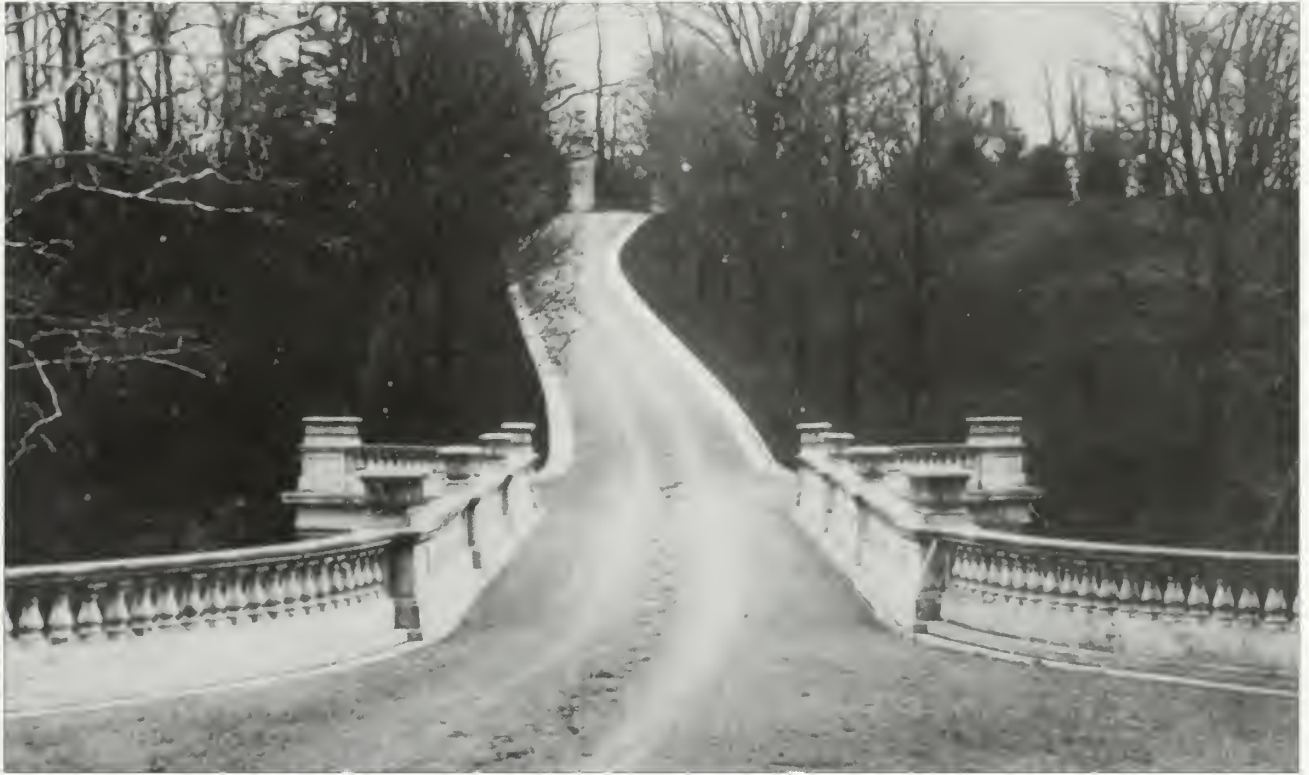
Figure 29. View of the White Bridge and the maple allée looking east toward the Main Gate, circa 1900. Photo by Charles Sylvester Piersaull (VAMA V-2504).

Historically, the allée was characterized by a double row of about ten pairs of maple trees of the same age spaced evenly between the main gate and the White Bridge (Figure 29). Today, at least twelve of the original trees survive and have matured into large specimens with trunk diameters of between thirty and forty inches. Some of the trees have been lost and have been replaced in kind with young trees, with the younger trees varying from small saplings of about three-inch trunk diameter to young trees with a diameter of ten inches or more. By virtue of the extant historic trees, the feature still reads as a formal allée of mature maples, but a continued policy of replacement in kind of individual trees as they die will continue to degrade this effect (Figure 30).

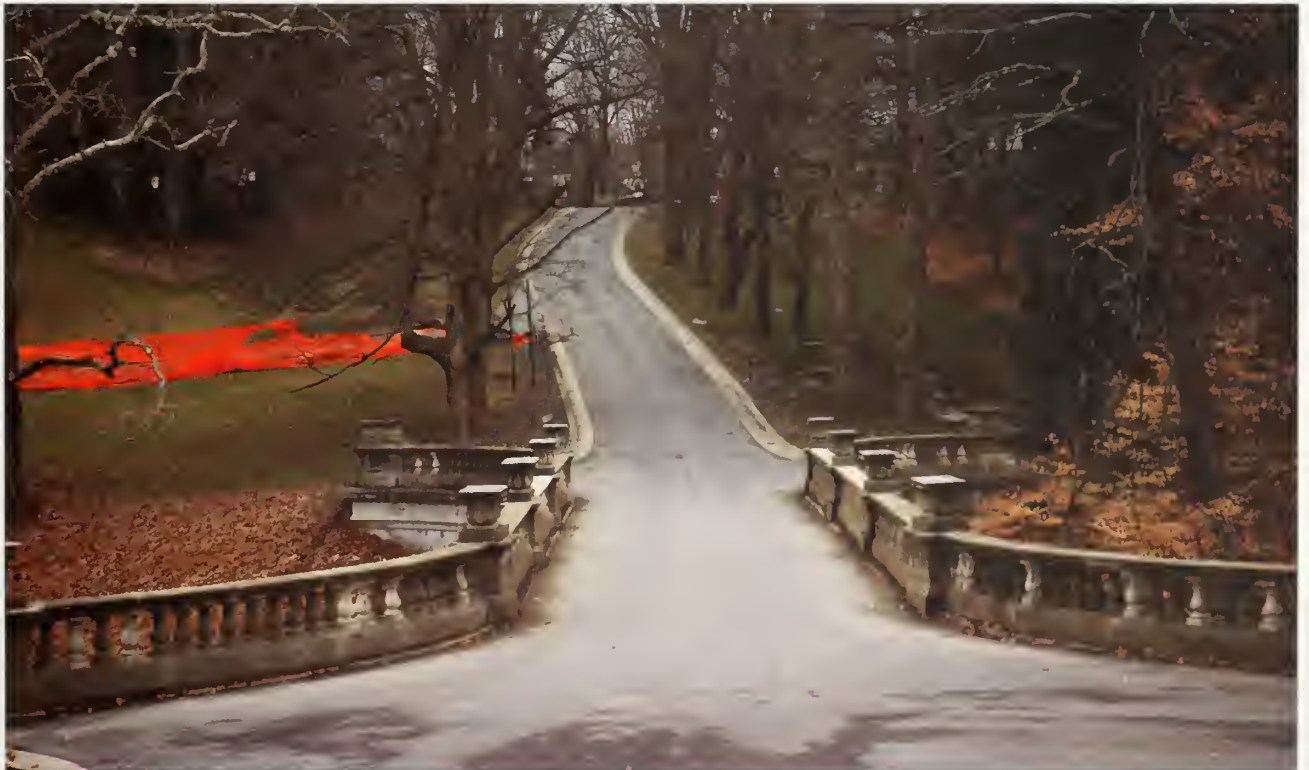
Figure 30. View of the White Bridge and the maple allée looking east toward the Main Gate, 2008. Orange construction netting associated with Route 9 Bridge construction is visible at left (OCLP 2008).

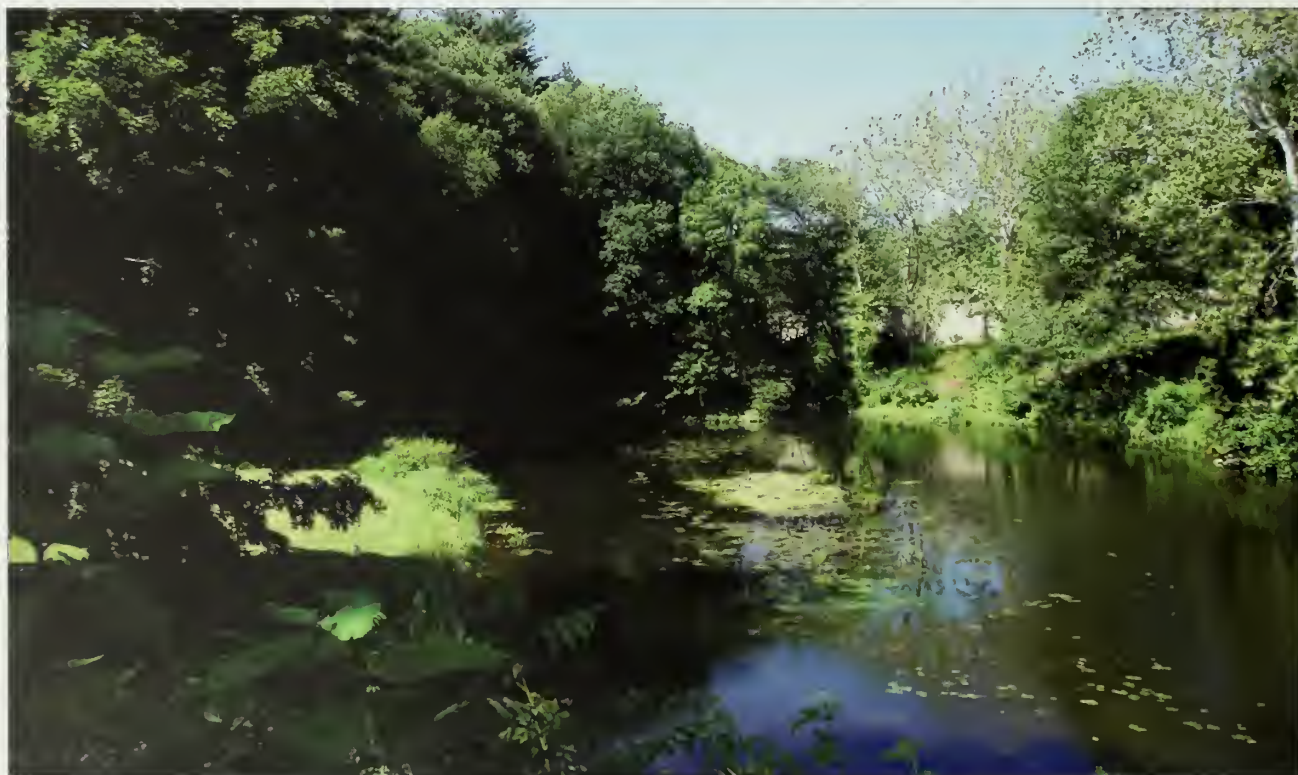
Figure 32. View of the entrance pond and Route 9 bridge looking north from the White Bridge, 2008. *Ailanthus* and other woody vegetation is evident in the foreground of the photo, and weeds and tall grasses are growing along the water edge beyond the mowable area. The photo also shows algae and other undesirable plants growing in the center of the pond as a result of increased silt and decreased depth (OCLP 2008).

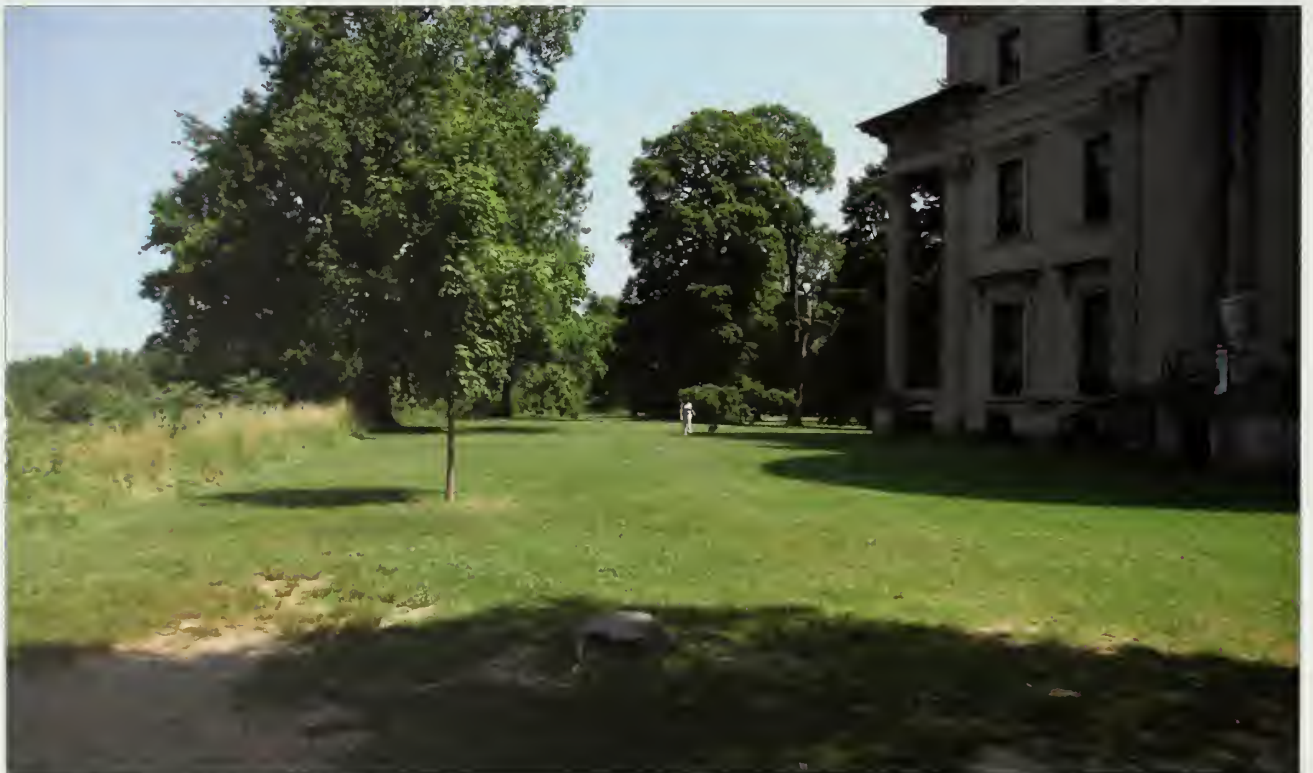
Figure 40. View of damaged lawn areas west side of the Mansion, looking north (OCLP 2008).

40.	View of damaged lawn areas west side of the Mansion, looking south, 2008.	130
41.	Plan drawn by Robert Cridland for the Mansion foundation plantings, 1923.	131

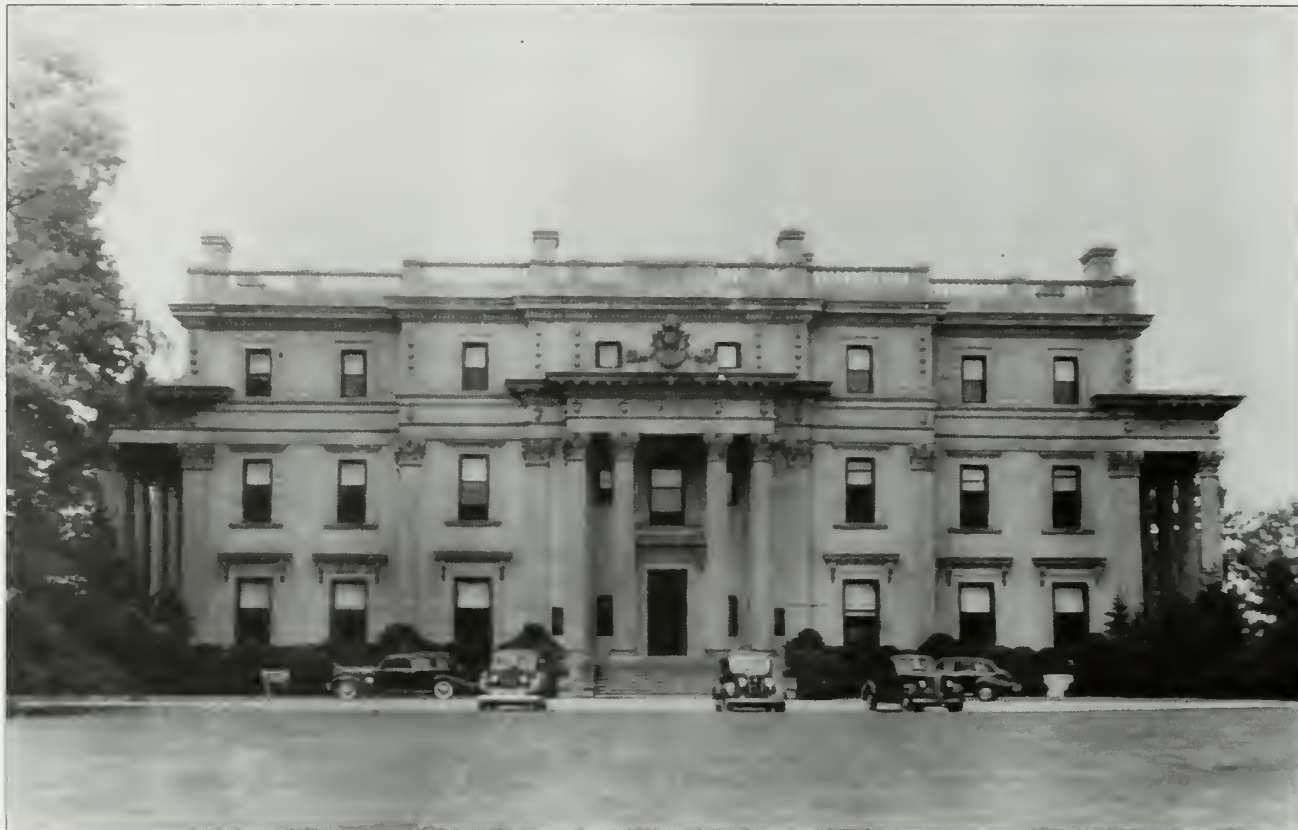
Figure 42. View of the Mansion looking west, showing the foundation plantings, circa 1940s (VAMA no. V-18).

Cridland designed, but by that time they no longer reflected the character that Cridland had intended (Figures 42 and 43).

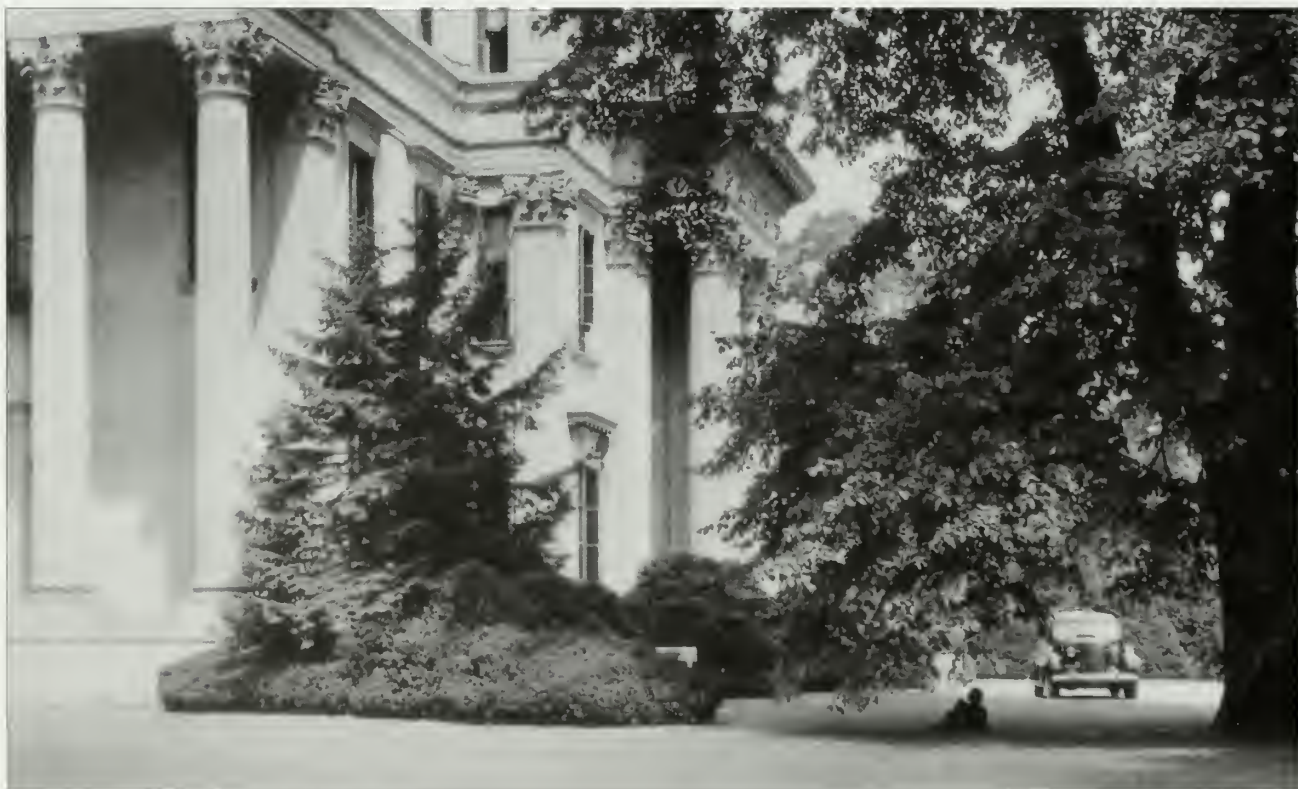
Figure 43. View of the Mansion foundation plantings looking north, circa 1940s (VAMA no. V-1980).

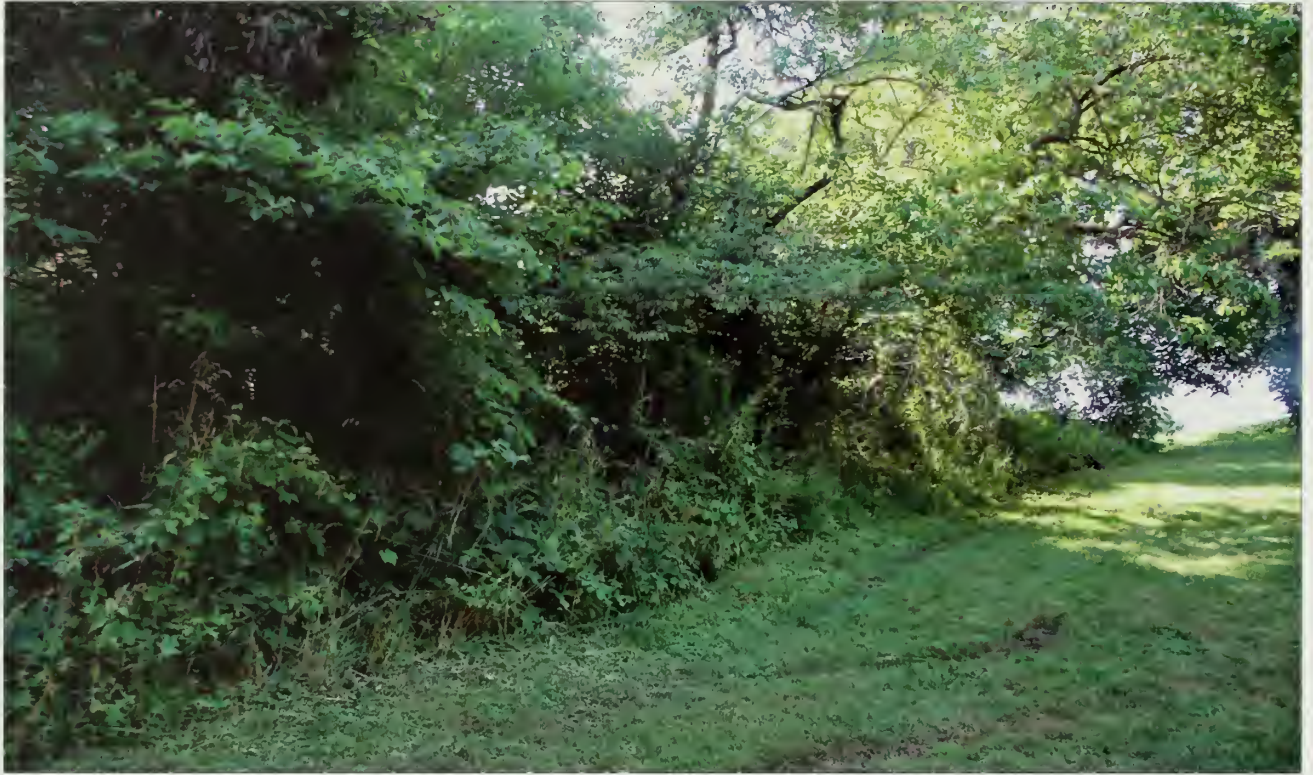
Figure 47. Dogwood and redbud grove south of the formal gardens looking north, showing dense vines and underbrush (OCLP 2008).

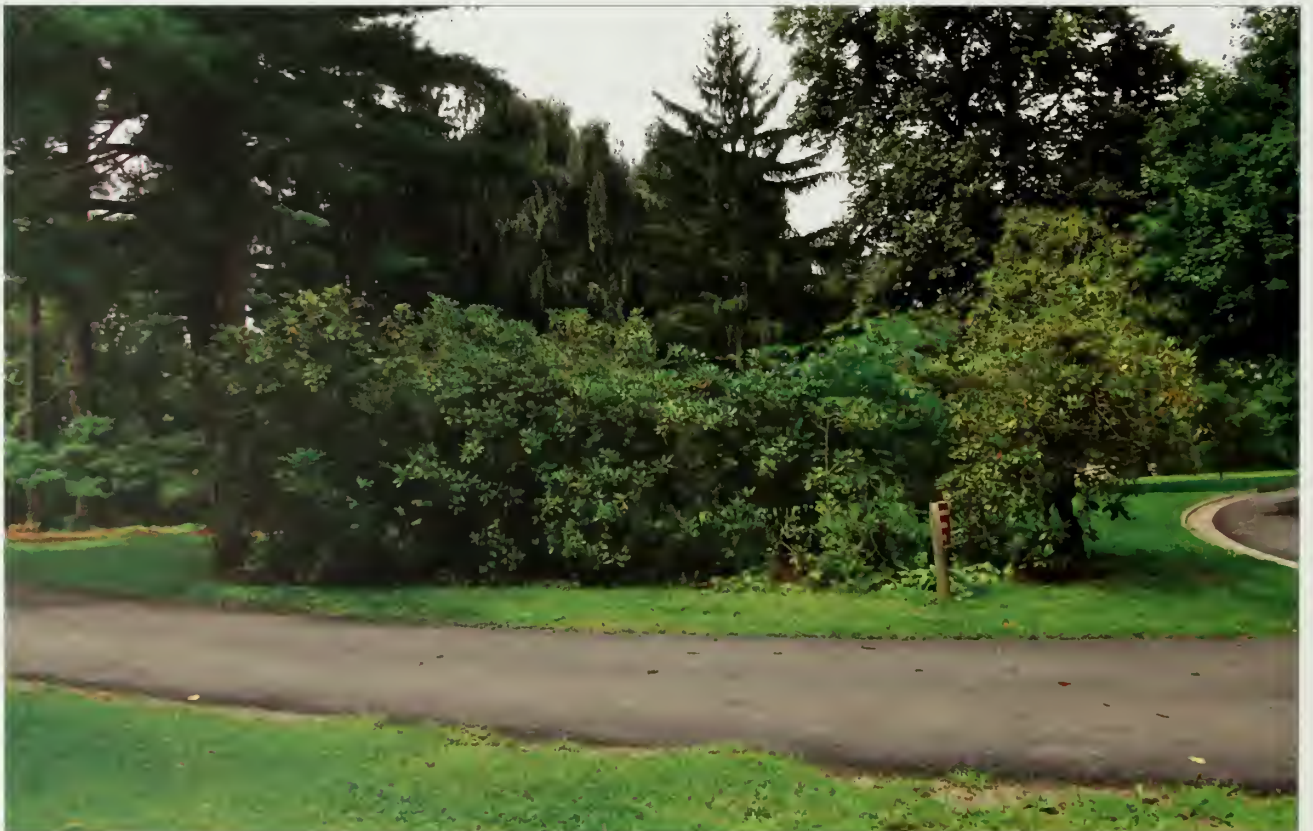
Figure 48. View looking north of a cluster of rhododendrons near the intersection of the entrance drive and road to the formal gardens. The grove consists of approximately eighteen plants in fair condition (OCLP 2009).

Several rhododendron plantings are located in the vicinity of the formal gardens and along the drives (Figures 48, 49, and 50). See also Zone 8 for azalea plantings west of the walk between the formal gardens and mansion.

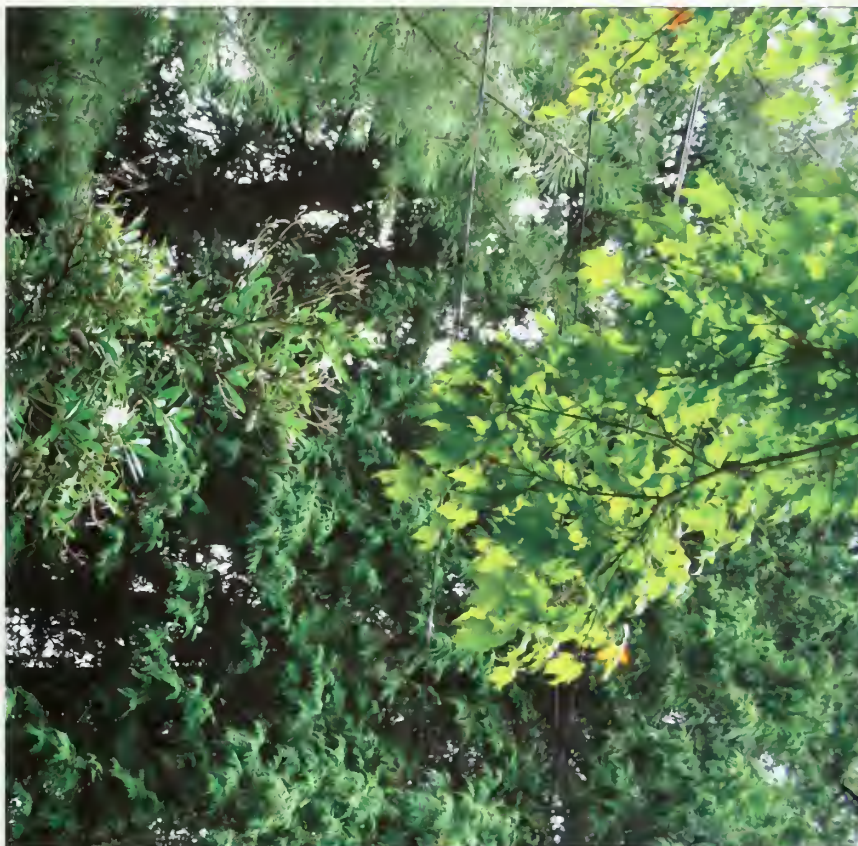
Figure 49. A single rhododendron in need of rejuvenative care remains to the south of the road to the formal gardens (OCLP 2009).

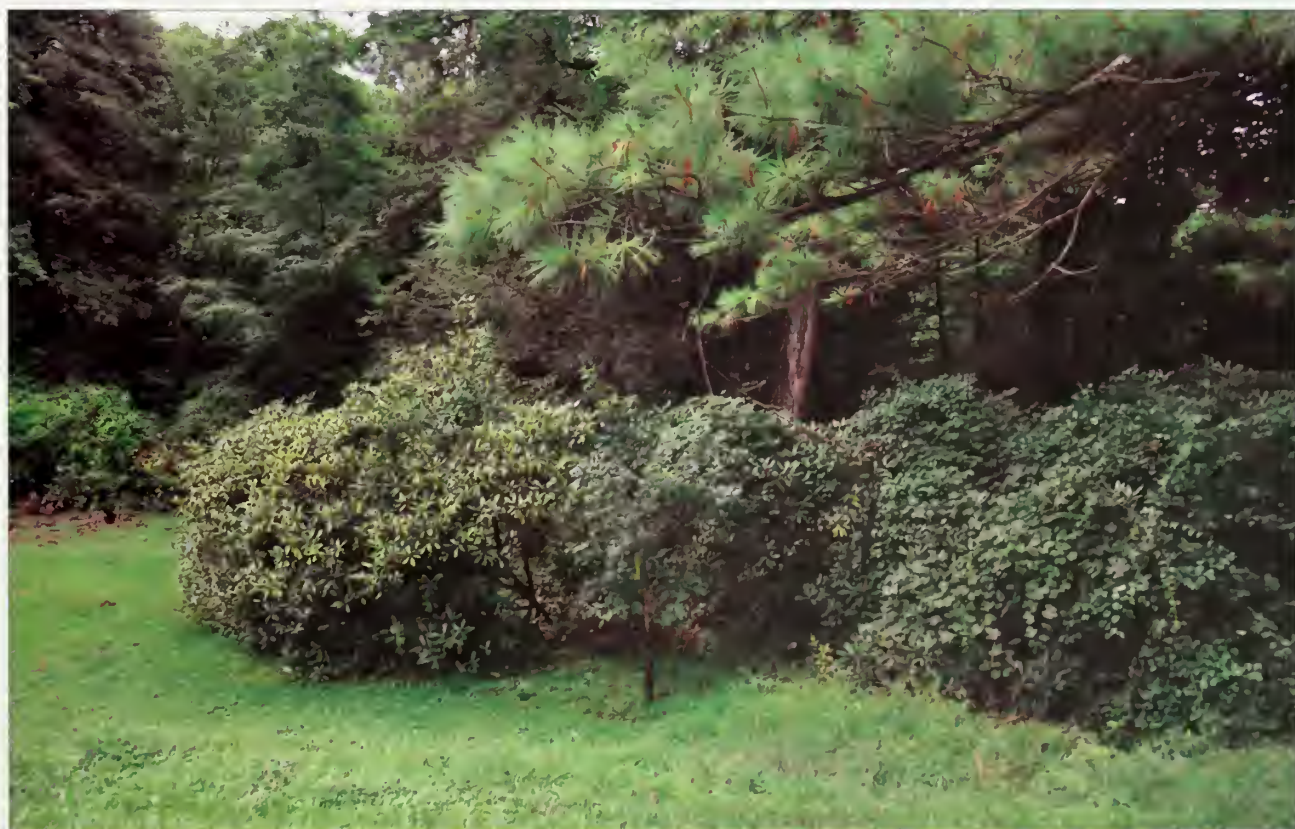
Figure 50. View looking east of grove of rhododendrons between the South Drive and Crum Elbow Creek. The rhododendrons are covered in vines (OCLP 2009).

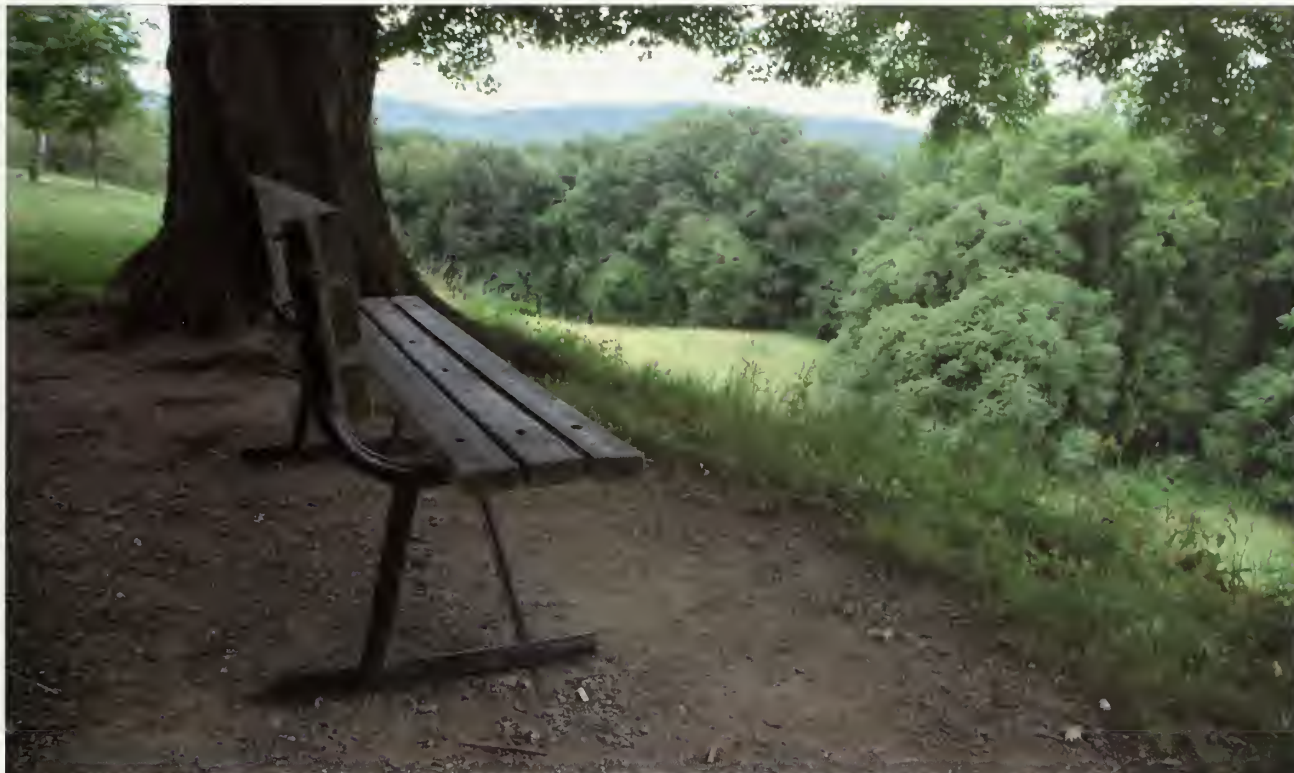
Figure 53. Damaged lawn area under the bench at the overlook north of the Mansion, view looking southwest (OCLP 2008).

53.	Damaged lawn area under the bench at the overlook north of the Mansion looking southwest, 2008.	139
54.	North Drive looking north, circa 1907.	139
55.	North Drive looking north, 1941.	140

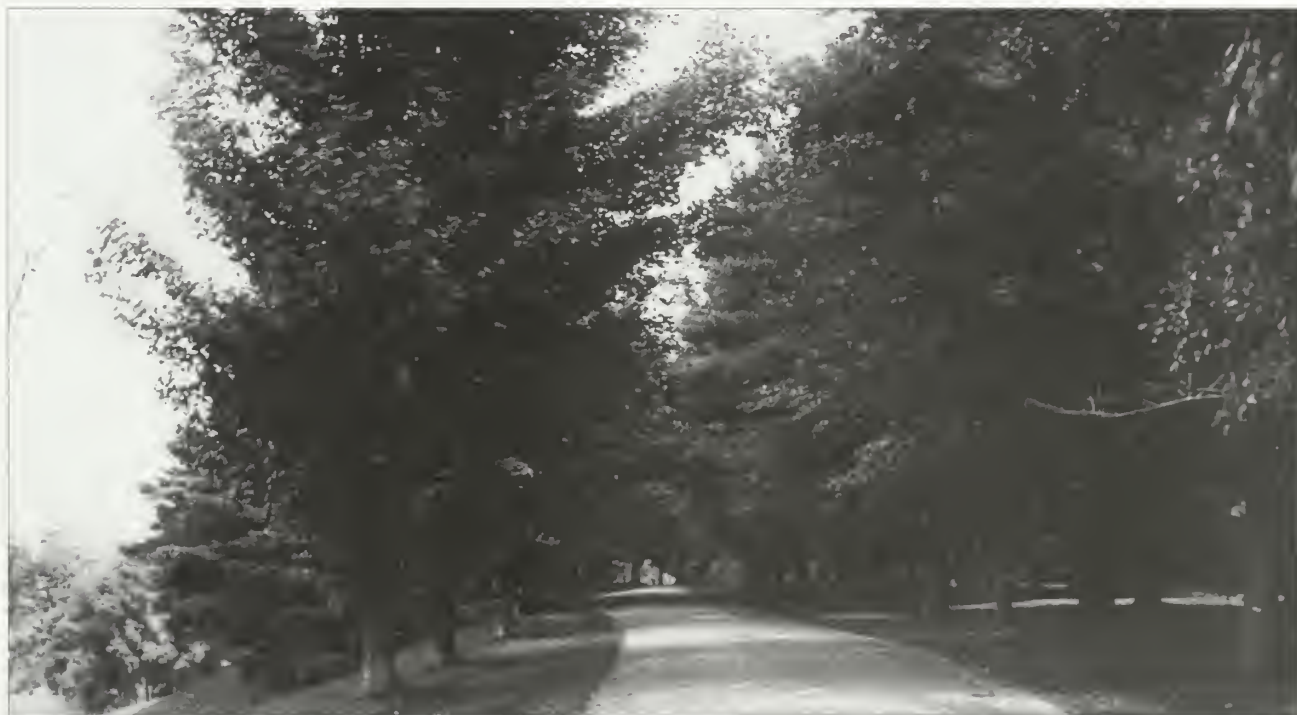
Figure 54. North Drive looking north, circa 1907. Photograph by Charles Sylvester Piersaull (Roosevelt Library no. 43-183-227).

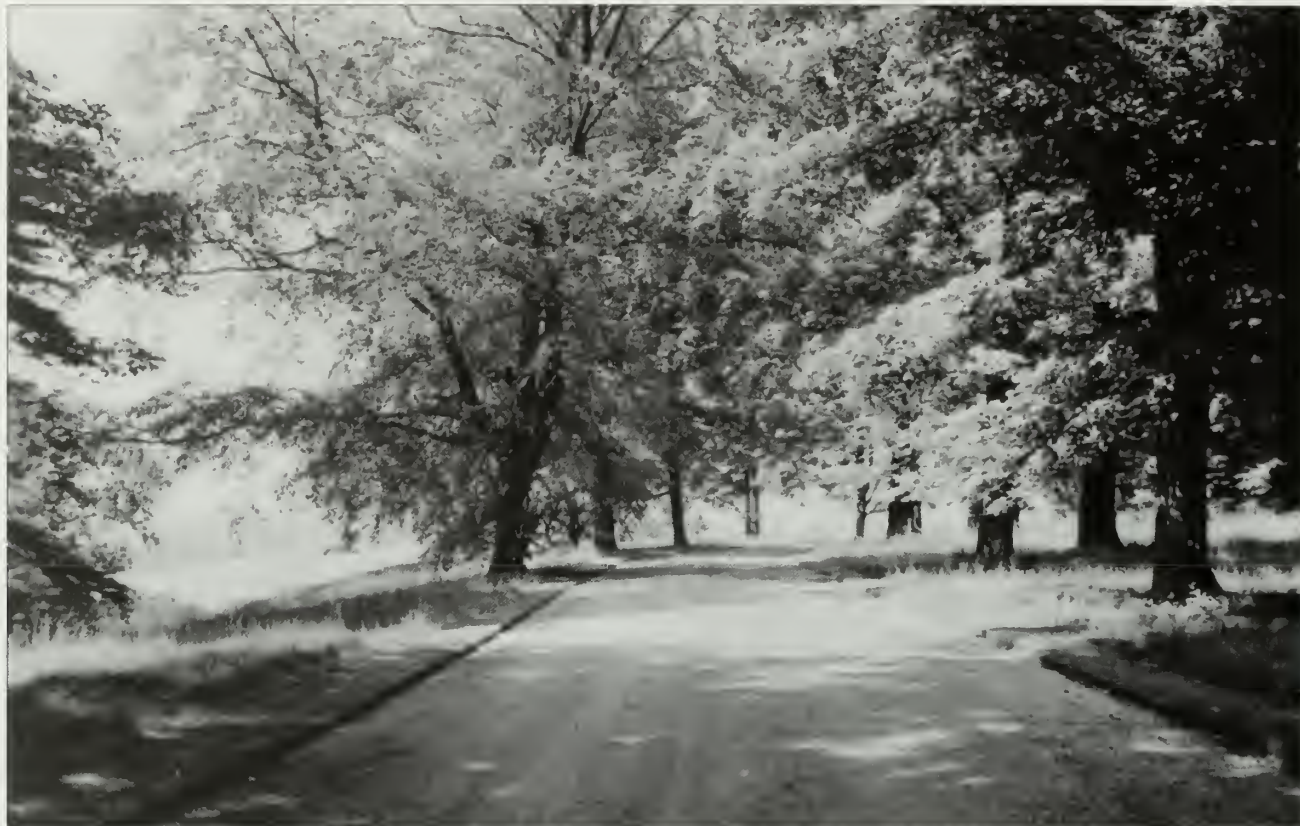
Figure 55. North Drive looking north, 1941 (VAMA V-731).

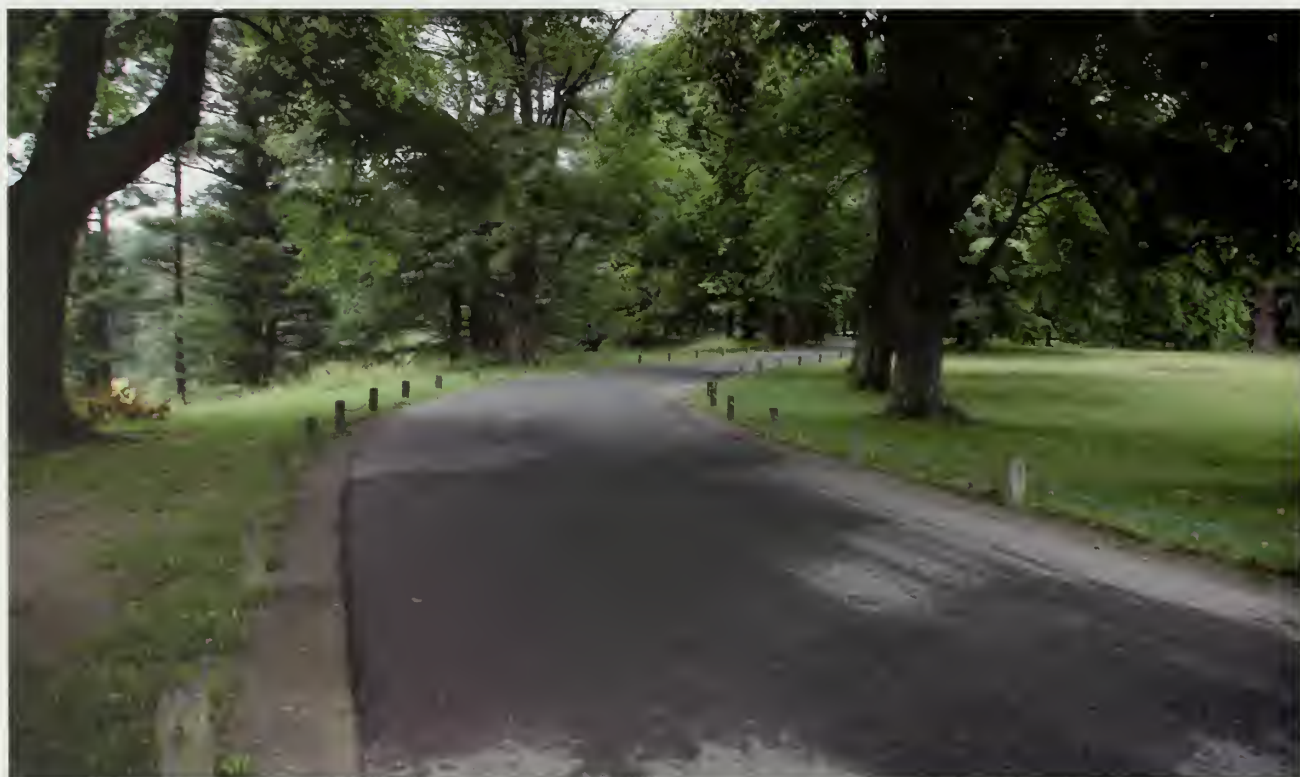
Figure 56. North Drive looking north, 2008. Although the character of the road has been changed somewhat from its historic conditions by the enlarged gravel shoulders and cable and post traffic guards, the road still displays much of the character that is evident in the historic photos above. Additional elements, however, such as curbs or footpaths, would significantly alter the drive's historic character (OCLP 2008).
